# CASE STUDY UNITED STATES DEPARTMENT OF THE TREASURY

# Case Study: U.S. Department of the Treasury

## Sloan Security Group Completes Complex U.S. Treasury Design-Build Security Project

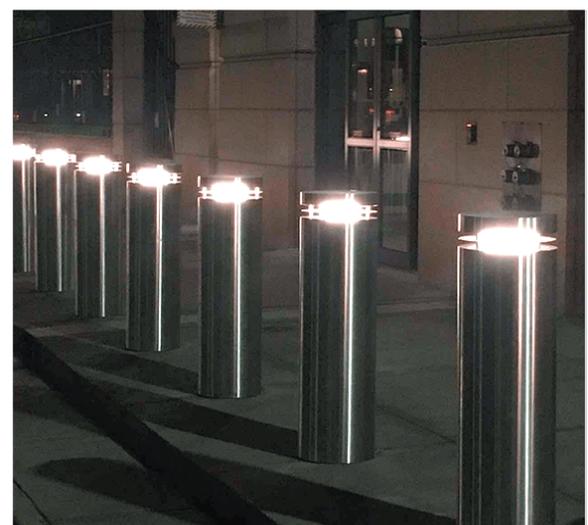
The process was especially complicated due to the existing sidewalk cross slopes exceeding ADA requirements and numerous utility manholes, valves, and building drains in the sidewalk.

The Bollard layout and crash-rated design requirements needed to be safely integrated around the utilities. The Bollards which are located in the sidewalk, and are on city/county property, were also subject to the U.S. Government's Interagency Security Committee (ISC) requirements.

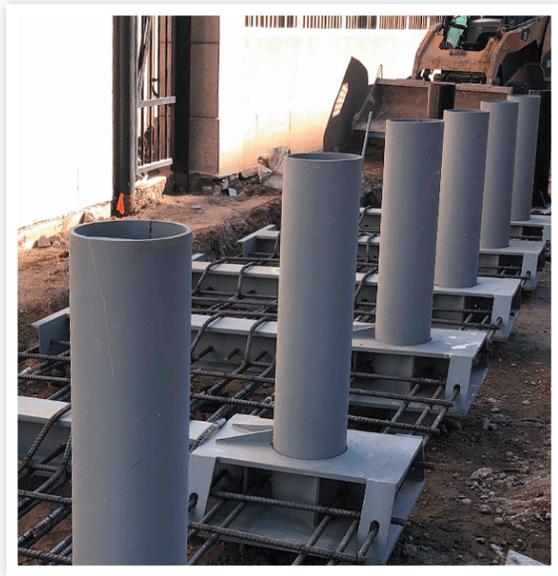
**Bollard Design and Manufacturing** - The Bollard design required numerous individually fabricated pieces to fine-tune the aesthetics and lighting implementation prior to production.

**Excavation and Installation** - The installation was complicated around the excavation and numerous encumbrances including manholes, vaults, electrical, fiber, water, and sewer lines in the sidewalk required careful planning and agency coordination. The setting of the Bollards to the correct elevation and location had to be precisely calculated due to the varying sidewalk slopes resulting from the ADA sidewalk requirements and existing manhole and utility valves.

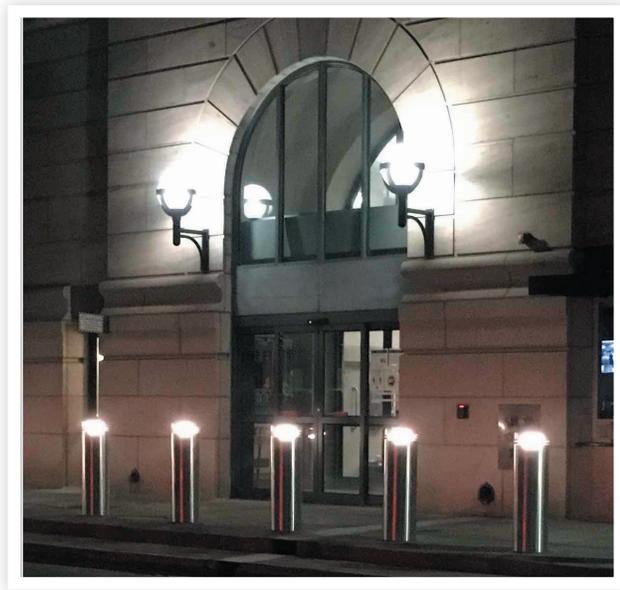
Sloan mobilized its construction team to complete the sidewalk demolition and installation of the 55 (M-50) Bollards which were engineered in both shallow and deep foundation configurations by Gibraltar and Barrier1 manufacturing. The architectural Stainless Steel Cover was a lighted design manufactured by Sloan. The project included approximately 70 CY of concrete removal, 70 CY of soil excavation, and placing 140 CY of heavily reinforced rebar and fiber 5,500 PSI concrete placed by our contractor, Denver Concrete Works. The electrical supply to the Lighted Bollards was installed by Empire Electric and required extensive conduit routing to connect to the 100-year-old building electrical system. All of this place took place within a busy urban environment with almost no staging or laydown areas.
